**REPORT OF MARINE SURVEY**

**PrePurchase Condition & Value  
of the vessel  
"Adventure"**

**1972 Bristol 42 Trawler**

**on  
4/2/2021**

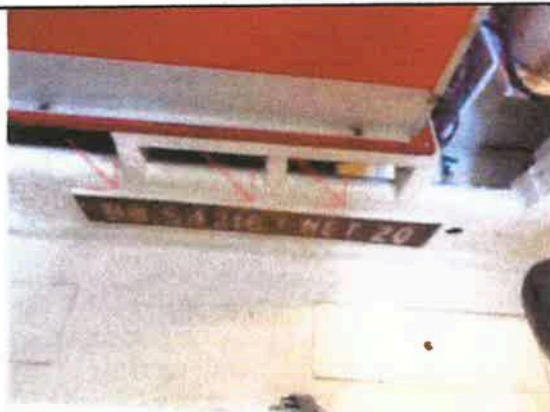
Official Documentation No: 542163 Expired.

Documentation current: Forms are available on line to make the fed doc current and transferred to new owner.

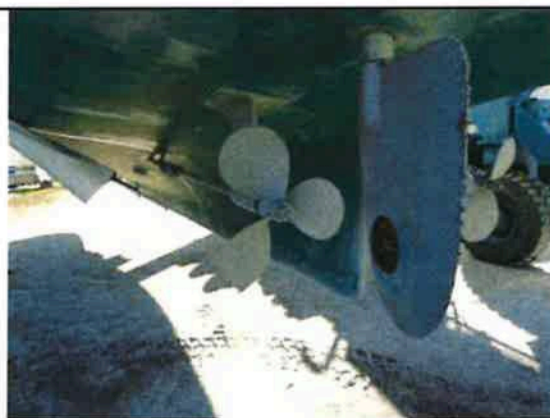
**Prop(s) description:** Prop has three blades and is made of bronze alloy, Props are in excellent condition. No bent, chipped or damaged prop blades. Prop nuts are secure and properly locked in place with jam nut and properly cotter pinned. The anti foaling paint on the shaft and props is blistering- remove the blistered areas. It may cause corrosion.

| <b>Findings:</b> | <b>Recommendations:</b> |
|---|---|
| blistered paint on shafts and props. | Remove blistered paint- may cause corrosion for lack of oxygen. |

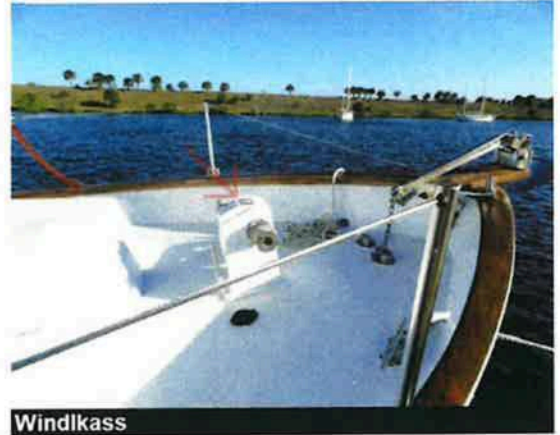
**Windlkass**

Powerwinch, w/ Chain gypsy,  
Rope gypsy The UP-Foot control  
properly powers up the windlass  
to raise the anchor.

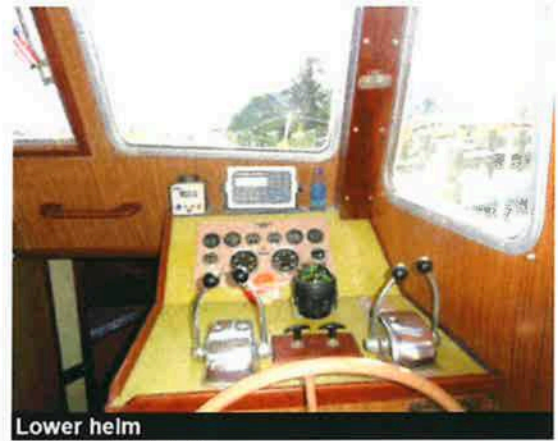
Lower helm

**Compass(es):** 3" Danforth Corsair, Appears functional. At both helms.  
**VHF radio(s):** Standard Horizon Powers up OK. at both helms.  
**Hailer(s):** Benmar Powers up - at both helms.  
**Autopilot(s):** Unipas. Functional- at both helms.  
**Depth sounder(s):** Datamarine Powers up OK, 2300. At both helms.  
**Other electronics:** When adding new electronics you may want to adjust your insurance coverage to reflect their costs.

**Antenna(s):** VHF.  
**High water alarm:** Not sighted. Since 2005, ABYC H-22 has recommended use of a high water bilge alarm for all vessels with accommodation spaces. Recommend compliance with ABYC.  
**Windshield wiper(s):** Test for starboard- functional. Portside did not function.

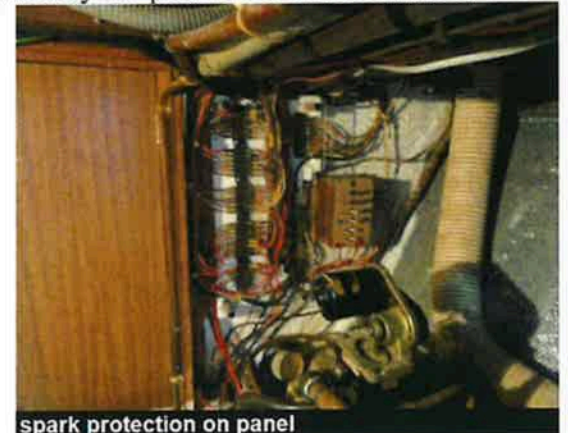
All terminals sighted have spark protection covers in compliance with ABYC E-11.5.

spark protection on panel

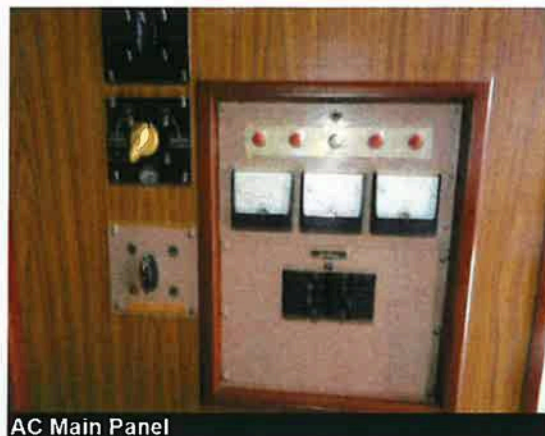
AC Main Panel

No GFCI protection sighted for 110V outlets in/near wet locations (galley, head) --  
RECOMMENDATION: Provide GFCI protection as currently recommended by ABYC E-11 and NFPA 302. (Install a GFCI equipped breaker in each wet location or as first outlet from power source in each circuit and test regularly.)

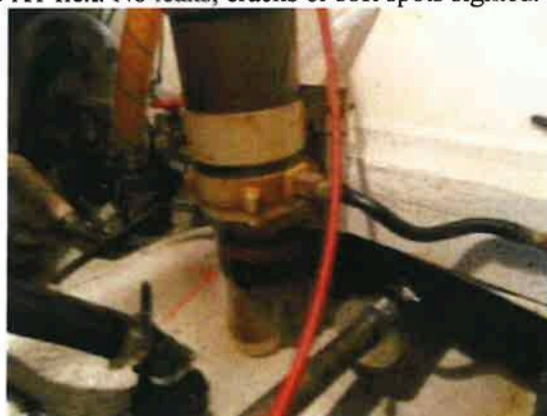
**Fuel filter(s):** Engine mounted. Remote mounted, No metal shield(s) in place- add metal shielding to plastic bowls.

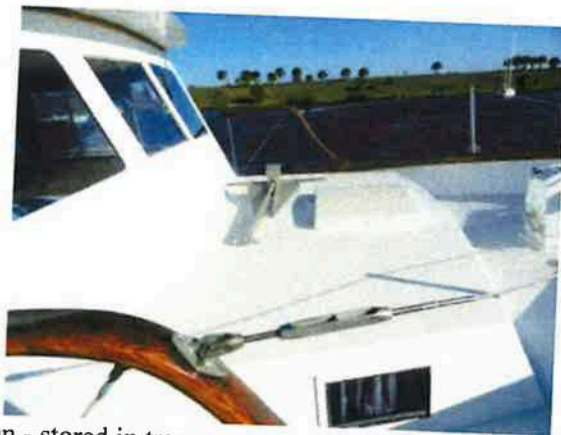
Danforth on front deck. Chokes show elevated moisture- rebed.

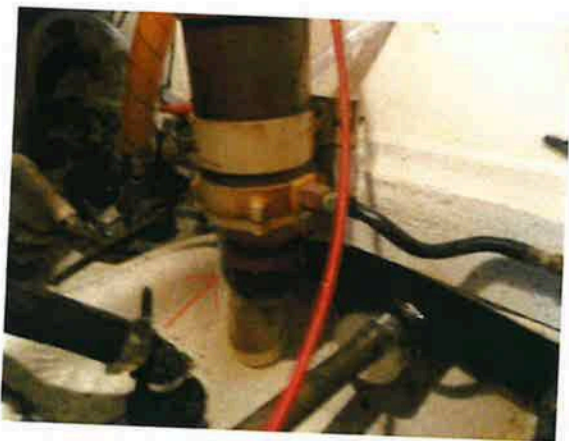
Engine mounted. Remote mounted, No metal shield(s) in place- add metal shielding to plastic bowls.

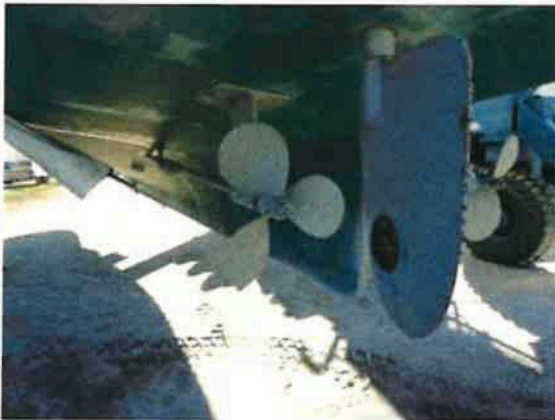
Prop has three blades and is made of bronze alloy, Props are in excellent condition. No bent, chipped or damaged prop blades. Prop nuts are secure and properly locked in place with jam nut and properly cotter pinned. The anti foaling paint on the shaft and props is blistering- remove the blistered areas. It may cause corrosion.

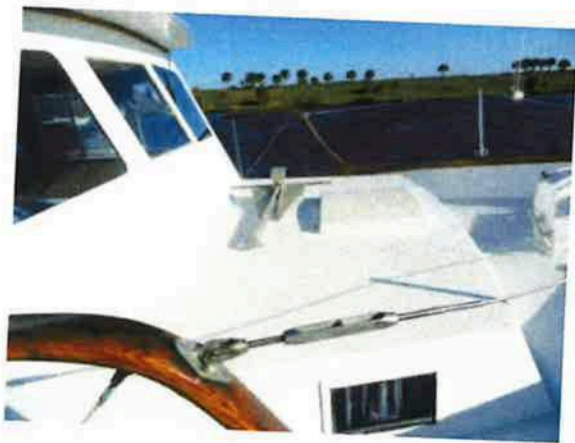
Danforth on front deck. Chokes show elevated moisture- rebed.
