**MILEY MARINE**  
Marine Surveying and Consulting

**1972 Bristol 42' Trawler**

***Venture***

## Report of Marine Survey

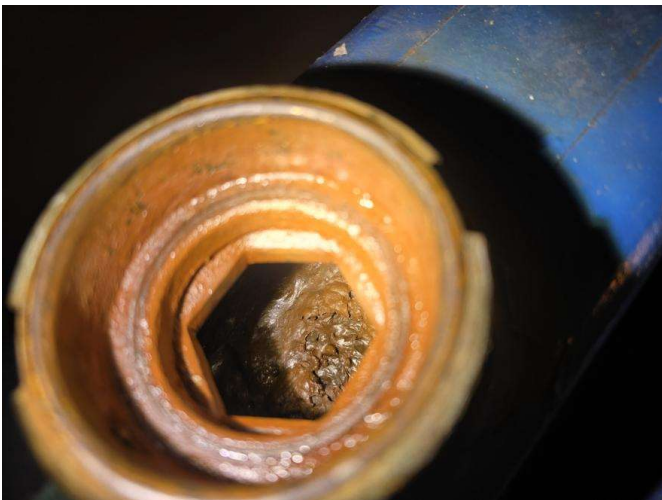
The coolant level in the starboard engine was low and showed significant rust/sludge buildup inside.

**Sludge in starboard engines heat exchanger**

*It is recommended that ALL oils and coolants, oil and fuel filters, impellers and cooling system zincs be changed now and a ship's maintenance log be kept.*

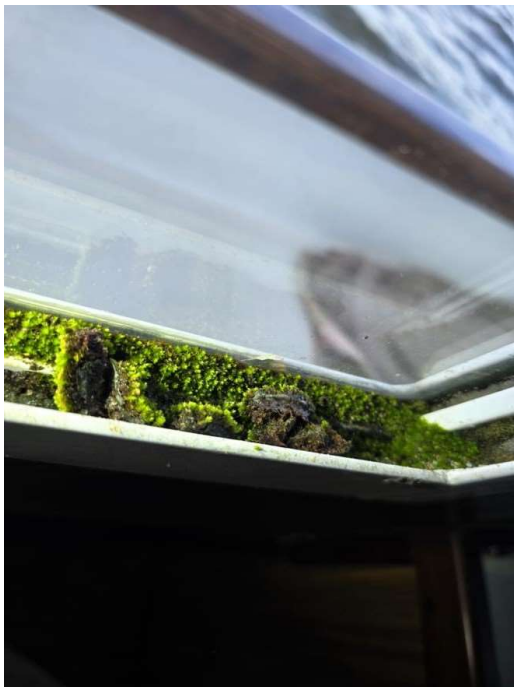
Wet/grime buildup was observed in the sliding tracks of each sliding glass window.

**Grime/mildew buildup in window tracks**

*Repair or renew as needed.*

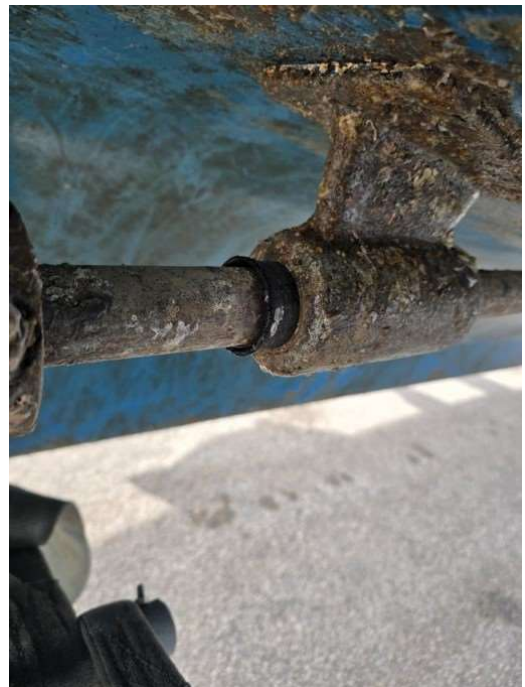
Cutlass bearings were all worn.

Cutlass bearings were loose on the port and starboard shafts, both aft and intermediate bearings. The starboard intermediate cutlass bearing was slid aft out of the strut.

**Cutlass bearing material loose and sliding out from inside strut**
