**REPORT OF MARINE SURVEY**

**PrePurchase Condition & Value  
of the vessel  
"Adventure"**

**1972 Bristol 42 Trawler**

**on  
4/2/2021**

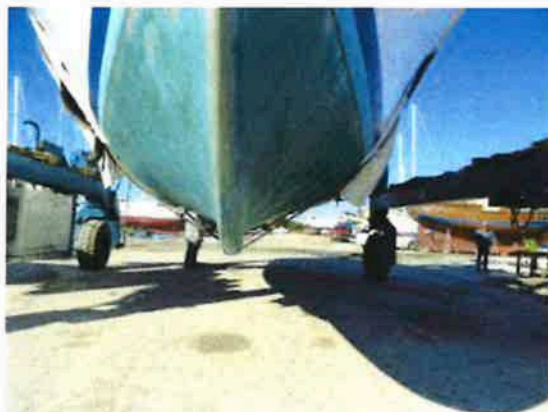
**Bottom paint:** Reported barrier coated in 2019. Some alabative bottom paint is gone- replace alabative paint before going to salt water.

**Osmotic blistering:** NO evidence of blisters was found on hull bottom during bottom inspection.

**Moisture/Delamination:** All random moisture meter readings on hull bottom and surrounding thru hull fittings were relatively dry with normal comparative moisture meter readings. No Delamination discovered when randomly testing with percussion hammer. IR camera used- No moisture or delamination sighted.

**Void(s):** None found.

**Grounding damage:** None noted.

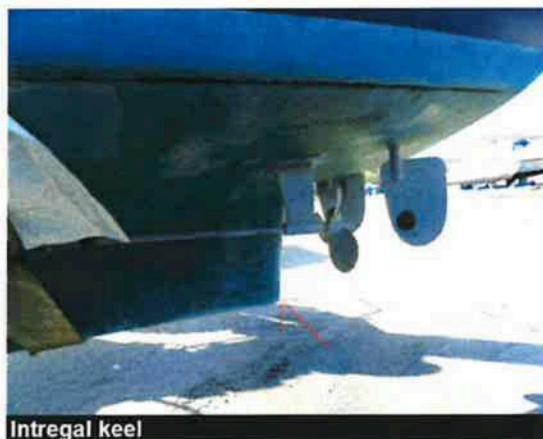
**Keel type:** Keel is molded in with hull.

**Keel condition:** Keel is well secured and well faired into hull. No cracks or separation sighted at hull to keel joint.

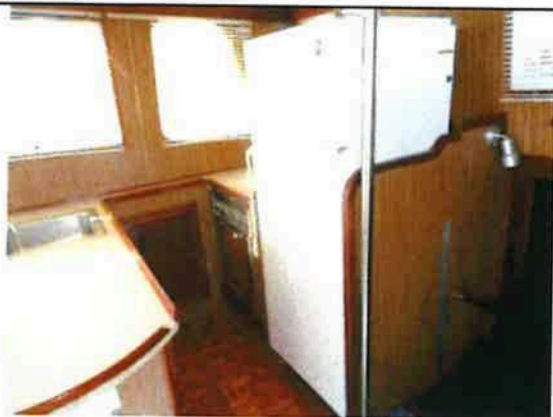
**Sink(s):** Stainless steel shallow well.  
**Water system:** Pressurized hot and cold.  
**Stove:** Princess. four burner, electric, with oven, Burners tested and are functional.  
**Refrigeration:** Upright, General Electric with freezer.  
**Microwave oven:** Black & Decker. Powers up OK and appears functional. Unit is not properly secured on counter. **RECOMMENDATION:** Any appliance should be secured from movement while underway to comply with ABYC A-3 recommendations. A large device/appliance left loose while under way on a counter, table or stove top can be hazardous to passengers and crew.

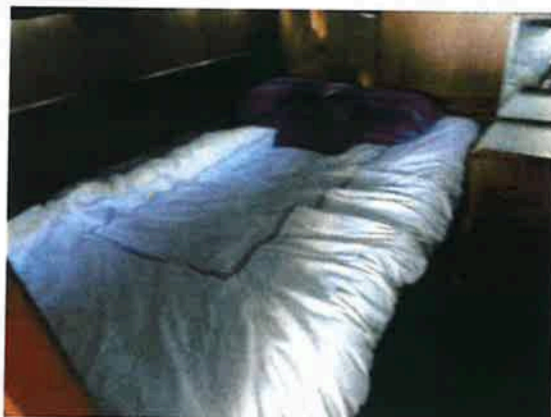
**Berths:** Four. plus sofa.  
**Master stateroom:** In Aft cabin area, Amenities include: Head w/shower. Mattress / cushions, Good condition.

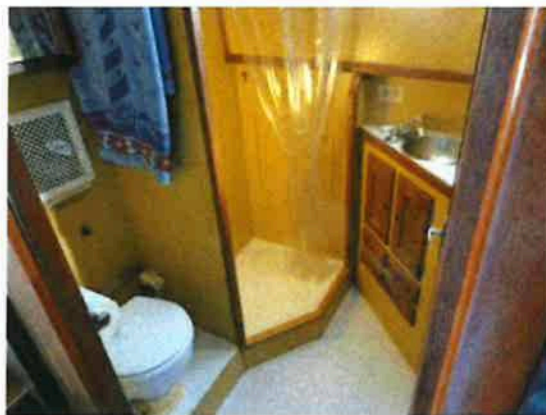
**Number/Location:** Two heads in aft cabin Forward.  
**Toilet(s):** Electric flush Appeared functional when tested. No leaks sighted.  
**Raw water supply:** Raw water intake thru bronze seacock.  
**Sink:** Stainless steel in both.

**Shower(s):** one in aft head. Sumps overboard- not tested.

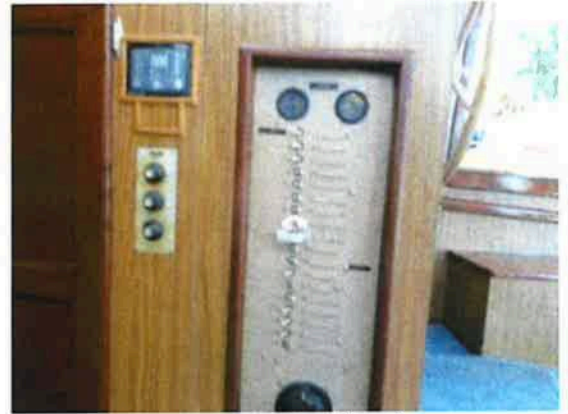
All DC circuits controlled from the helm station dash and panel.

All D.C. circuits are adequately protected by branch or switched breakers.

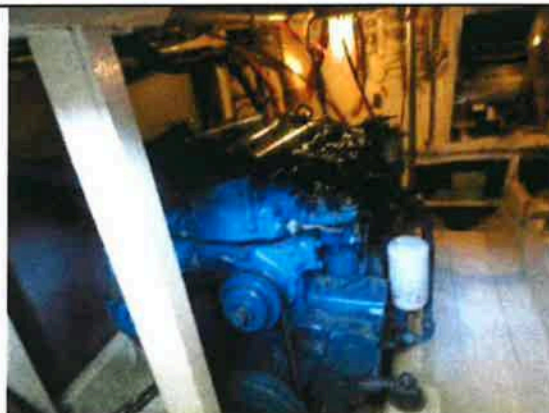
**Engine specifications** Two, Perkins, Inboard model 6-3544. using Diesel fuel Four cylinders, In Line 6 cylinder, Naturally aspirated.

**Engine serial no(s):** Engine serial no tag was sighted or unreadable on the engine.  
**Engine(s) hours:** Port hrs: 3240. Starboard 3052.  
**Raw water hoses:** Good condition-No cracks, soft spots or leakage sighted.

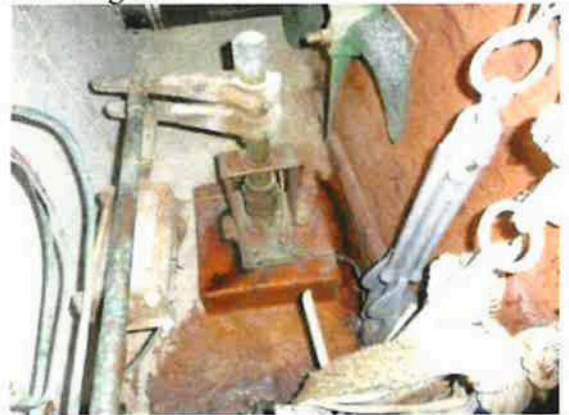
**Type:** Hydraulic lines and ram cylinder with attached on rudder stock or tie bar. Electronic controlled steering motors are used to move the lower propulsion pod. Latham hydraulic steering. Rack & Pinion gear.  
**Mounting(s):** Cylinder & ram actuator well secured-no leaks sighted.

**Steering tie bar:** Well mounted with rudder steering arms connected by a steel lateral bar.  
**Lines and fittings:** Copper, Flex hydraulic lines. No leaks sighted.  
**Pressure/reservoir tank:** Power steering fluid reservoir is Full. Located in transom- accessed in round hatch on aft deck. Site tube on canister.  
**Rudder stock(s):** Visually sound.  
**Packing glands:** Appear well sealed- No leaks sighted.  
**Condition summary:** Serviceable.
